3000-HP ROLLER GEAR TRANSMISSION DEVELOPMENT PROGRAM.
VOLUME V AIRCRAFT TIEDOWN TESTING

3000-HP ROLLER GEAR TRANSMISSION DEVELOPMENT PROGRAM
Volume V - Aircraft Tiedown Testing

Sikorsky Aircraft
Division of United Technologies Corporation
Stratford, Conn. 06602

Final Report

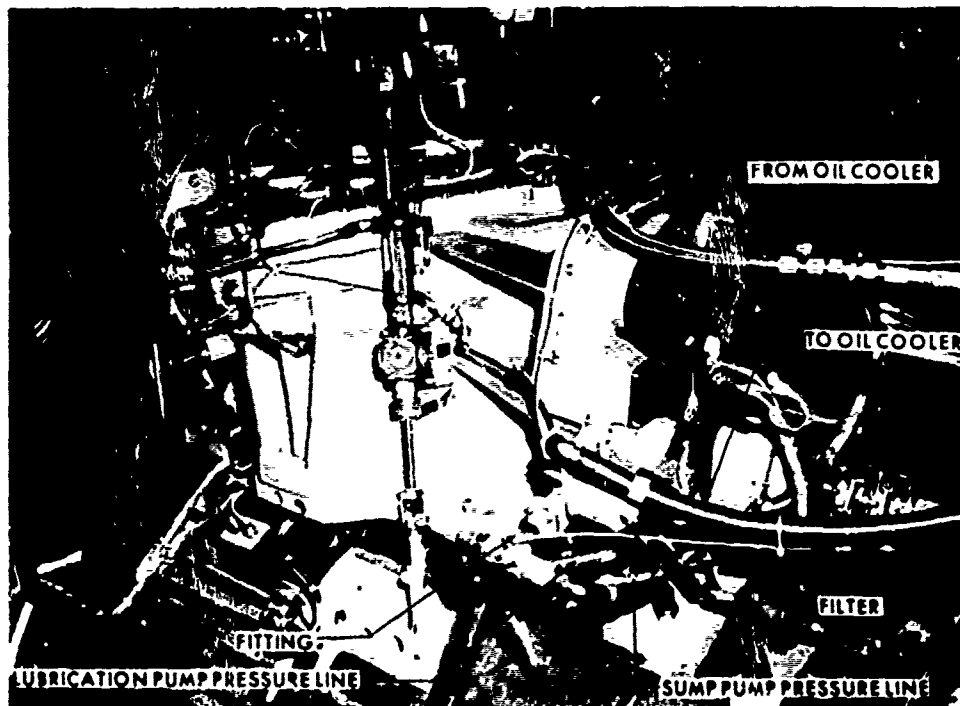
Figure 45. Lubrication Components, Roller Gear Transmission

The main gearbox "Air Maze" filter was checked after 13.6 hours of test. After reinstallation, it began to leak due to distortion of the filter cover. A new cover was installed and the problem was eliminated. Figure 45 shows the location of this filter and the lube oil fitting which leaked oil at 29.5 test hours, when the fitting threads were found to be stripped due to too shallow engagement. The problem was solved by reworking the fitting to ensure deeper thread engagement. No further leakage occurred.

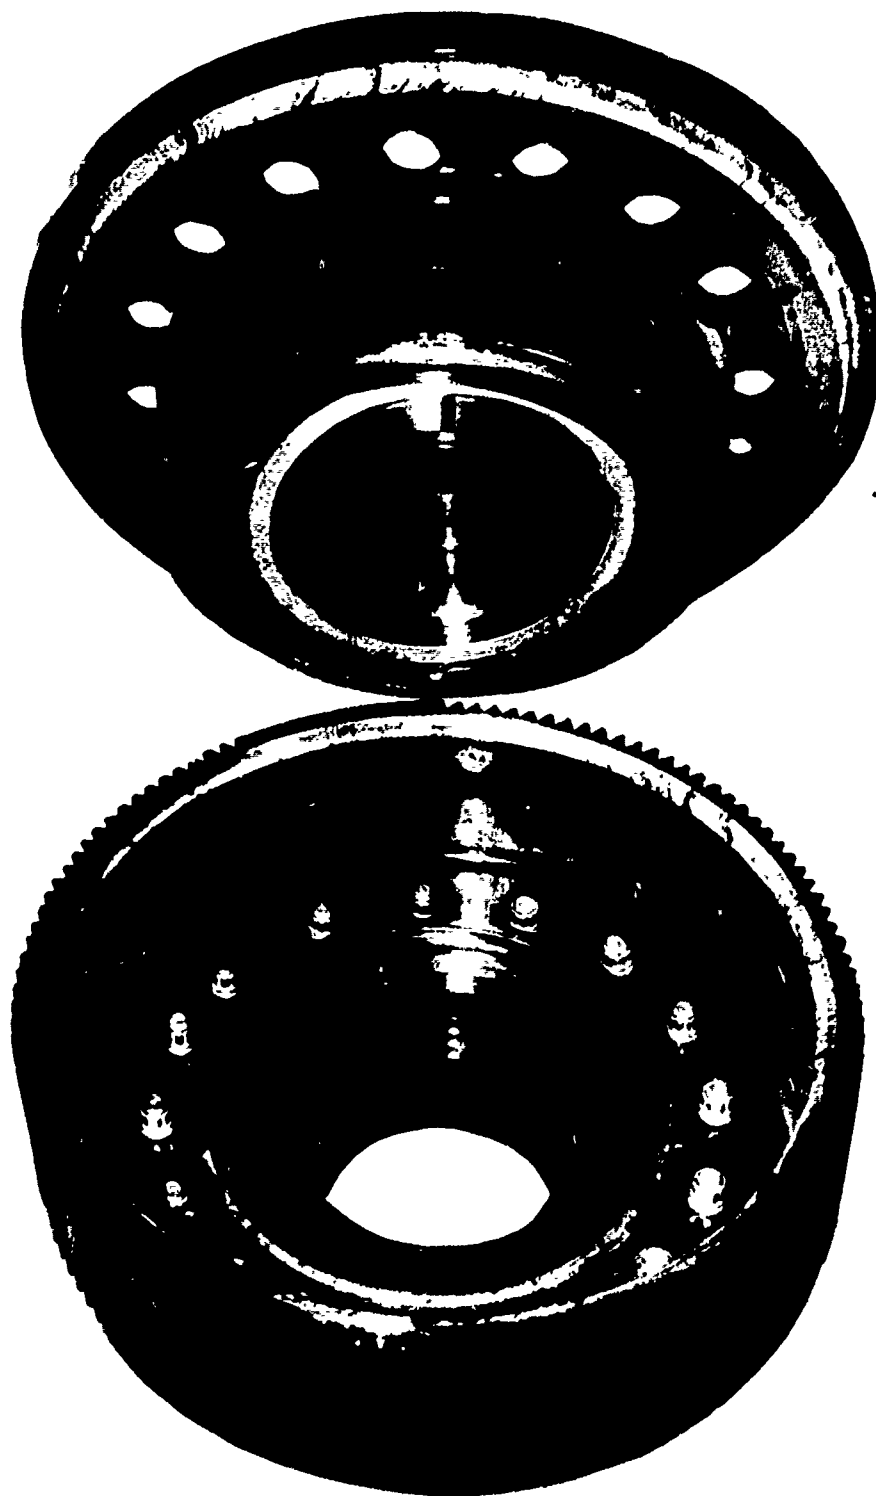
Figure 62. Fractured Second-Row Gear, S/N 62

The wear patterns on the gears was, except for some slight debris damage, excellent. The rollers themselves showed no damage.
